ESA-EA Report 97-1
Issued August, 1997
Revised June, 1998

***A STUDY OF THE SITE VIBRATION
CHARACTERISTICS FOR THE FECHIN INSTITUTE
IN TAOS, NEW MEXICO***

Los Alamos
National Laboratory

*Marcie S.H. Kam
Brian Hoerst
Phillip J. Cornwell
Charles R. Farrar
Isaac F. Salazar*

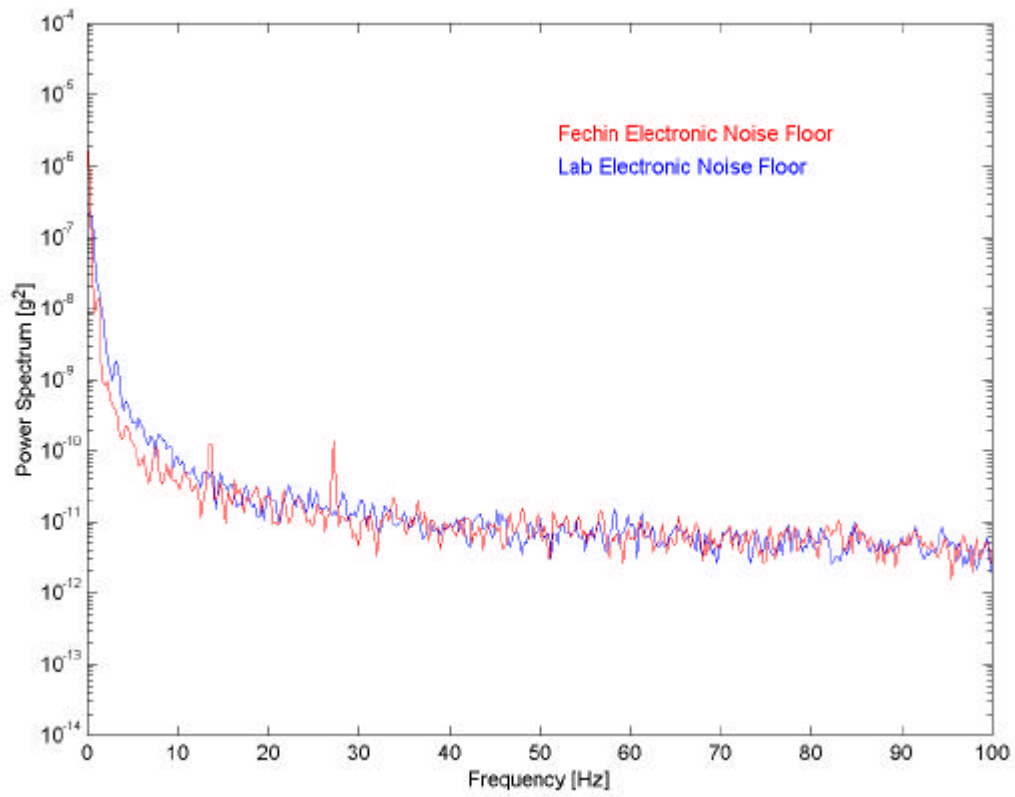
Figure 6. Electronic Noise Floors in the Lab and at the Fechin Institute

Figure 6 compares the electrical noise found in the lab, and the noise found on site. As expected, the noise levels are very low, at approximately $4 \times 10^{-11} \text{ g}^2$ above 35 Hz in both cases. The noise levels under site conditions are comparable to those found in the lab. We can conclude that the instrumentation is not sufficiently sensitive to pick up any differences between the floor noise in the lab and the ground noise on site. Peaks in the power spectrum found in the site vibration noise measurement at approximately 14 and 27 Hz could be caused by vibration sources specific to this site.

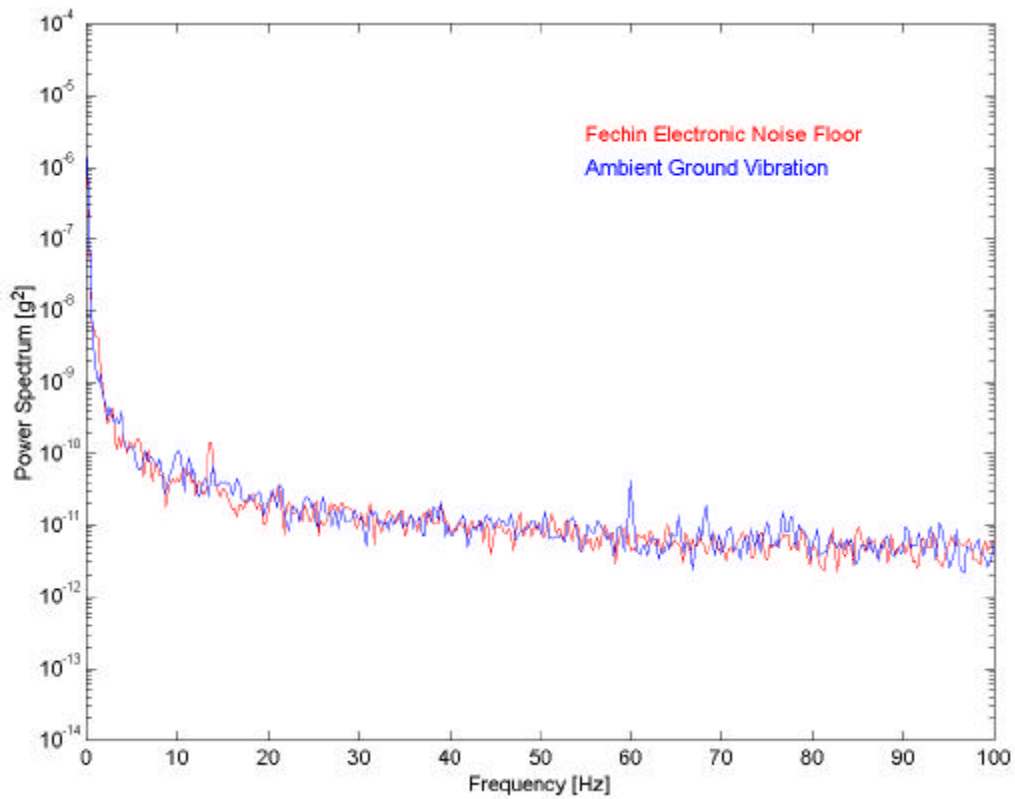
Figure 7. Electronic Noise and Ambient Ground Vibration at the Fechin Institute

When an accelerometer was mounted on the aluminum block in the soil, one would expect to see some differences between measurement of the ambient background vibration measured in the soil when compared to those measured with the tripod setup. Comparison of the ambient ground vibration with the noise level of the measurement system on site is shown in Figure 7. The ground noise is nearly identical to the electrical noise in the system, which shows us that vibrations at this site are very low-level, and comparable to the electronic noise floor in the vibration measurement system. The spike at 60 Hz in the ambient ground vibration power spectrum is most likely caused by a nearby power source.

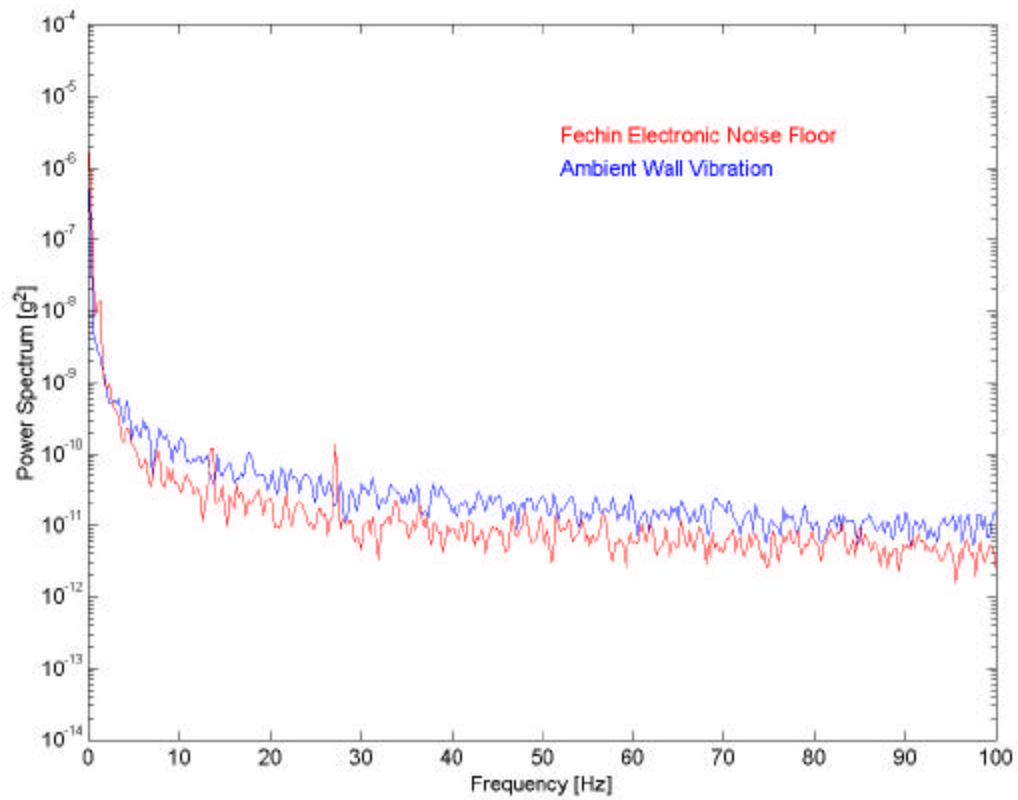
Figure 8. Electronic Noise and Ambient Structure Vibration

However, differences between the on site vibration floor and the vibrations picked up in the structure itself are more obvious. Although also very low-level, the vibrations measured with the wall-mounted accelerometer are about 20 times as large as the noise floor. Figure 8 indicates that the measured wall vibrations above 6 Hz are at least detectable by these instruments.

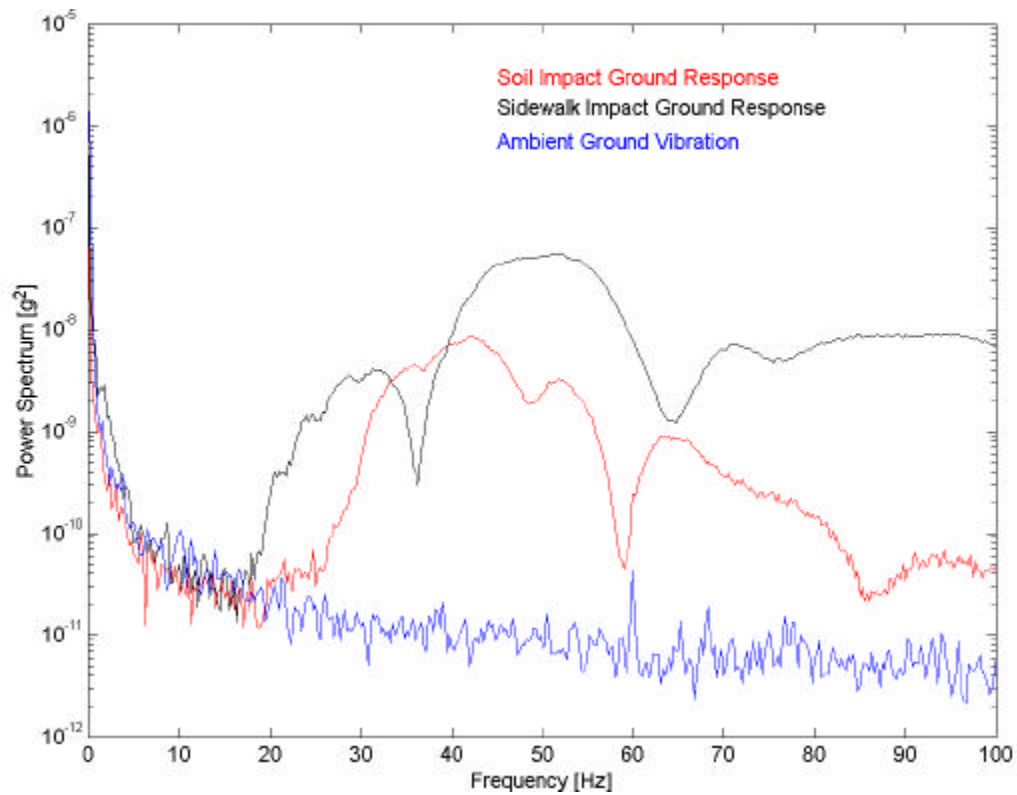
Figure 10. Ambient Ground Vibration and Hammer Impact Responses

Figure 10 shows the differences between the dirt and concrete impact power spectra, as well as the ambient ground vibration -- the accelerometer response without any forced excitation. The differences in spectra shape are due to the different damping characteristics of the dirt versus the concrete and the location of the hits. A diagram of the impact locations is shown in Figure 11.

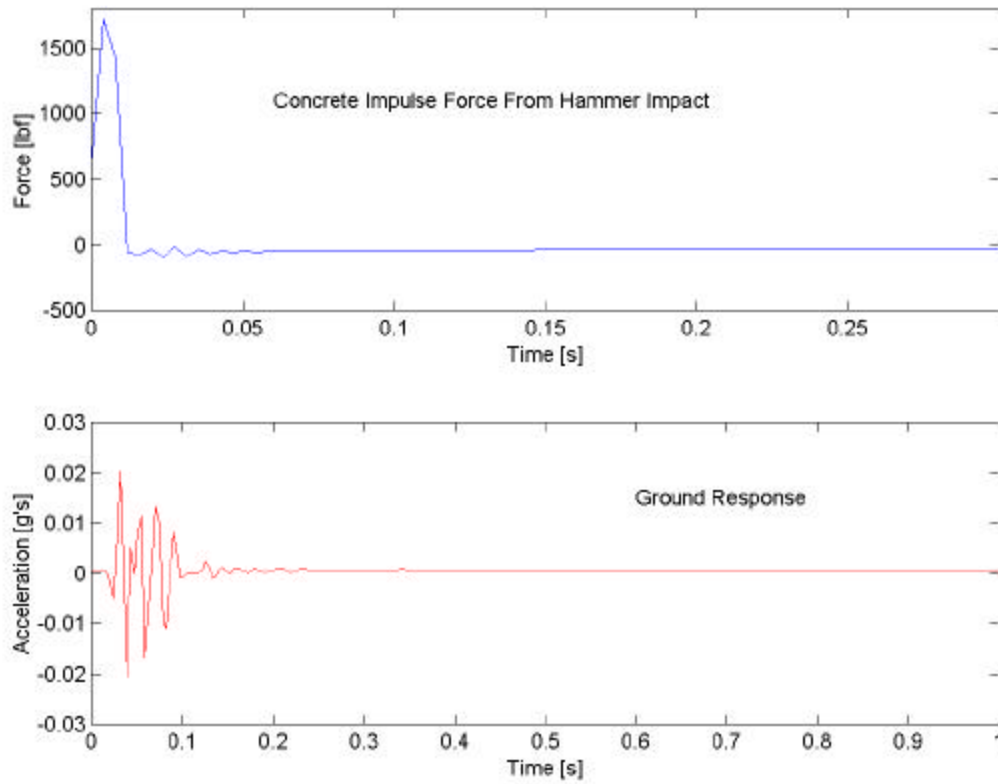
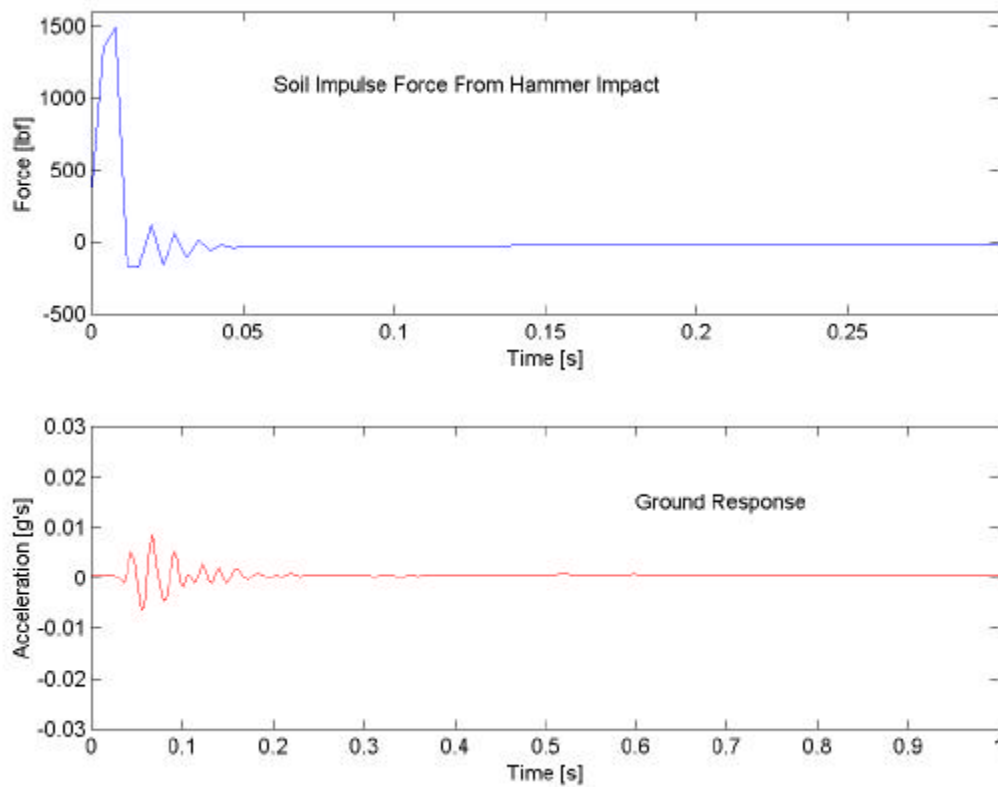
Figures 12 and 13 show the differences between the time histories of the impulses, and compare the two impulses to their respective responses. As expected, the concrete impulse had a much sharper peak and its acceleration response decayed more quickly than the that of the soil impact. Although the soil impulse was in closer proximity to both accelerometers, the stiffness of the concrete allowed a force of higher magnitude, and therefore an impulse response about double of that created by the impact to the soil. In both cases, the acceleration responses lasted approximately 10 times longer than the hammer impulses.

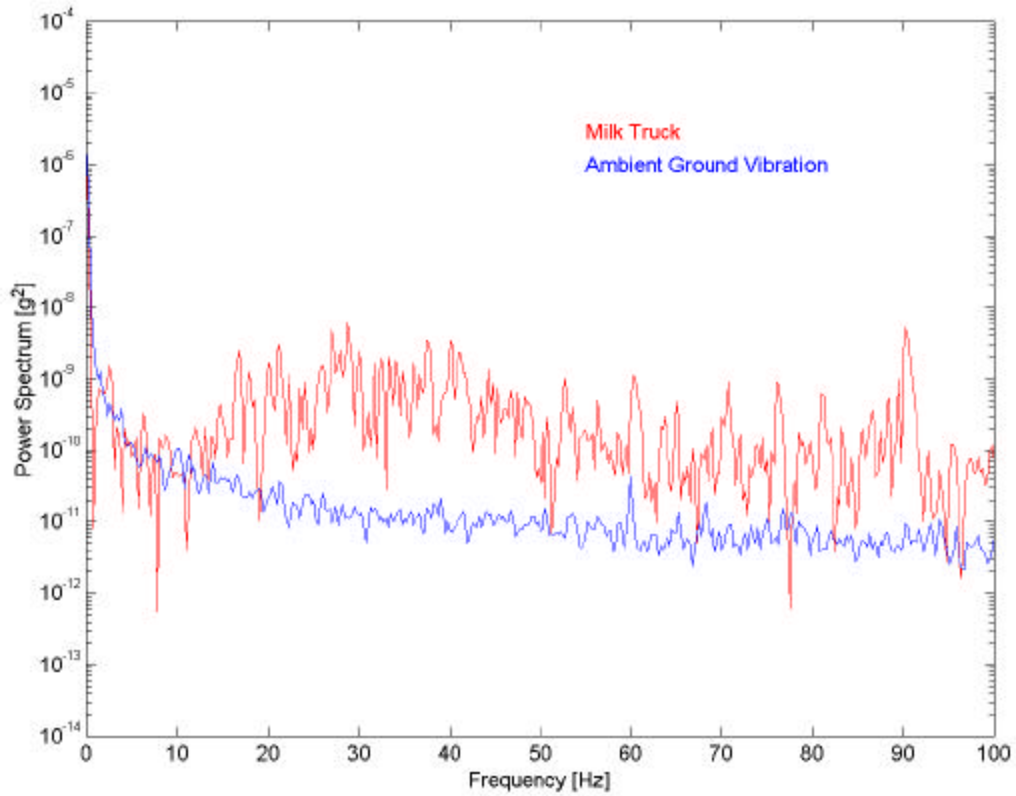
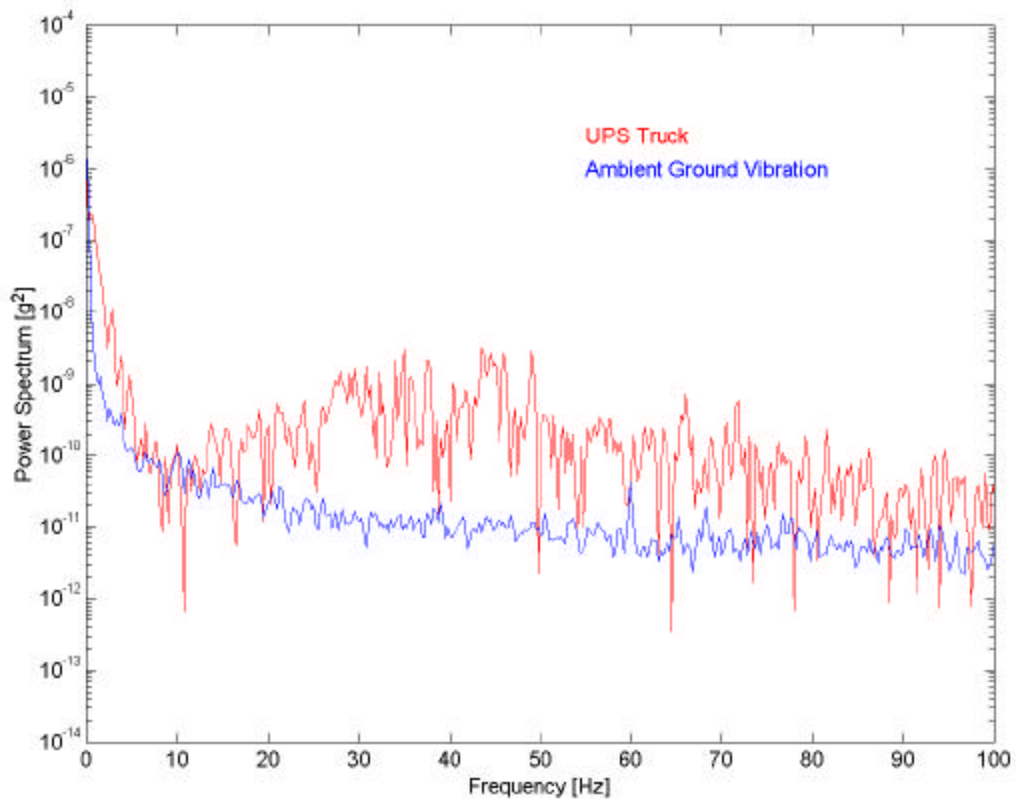
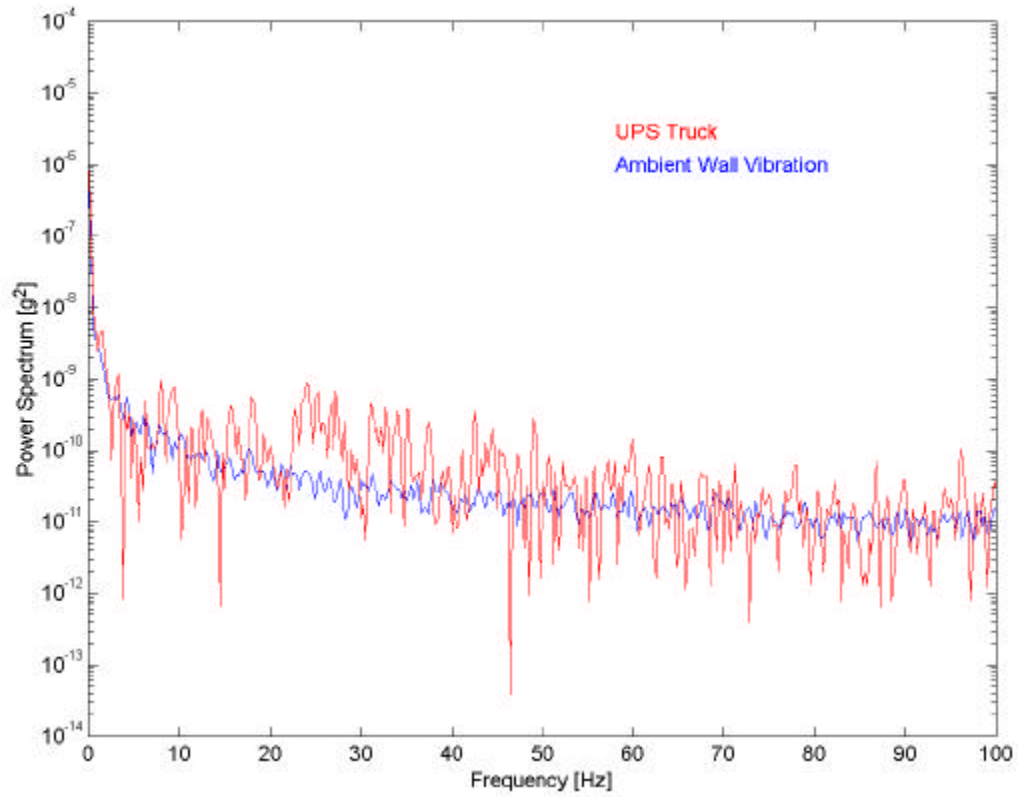
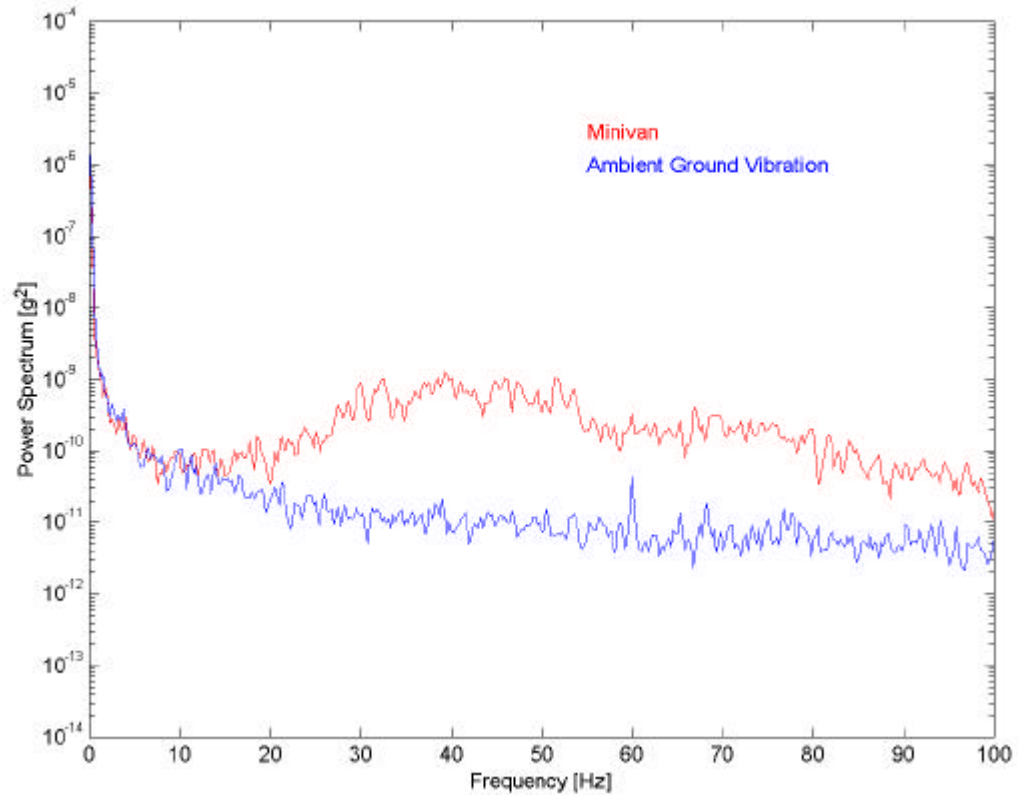
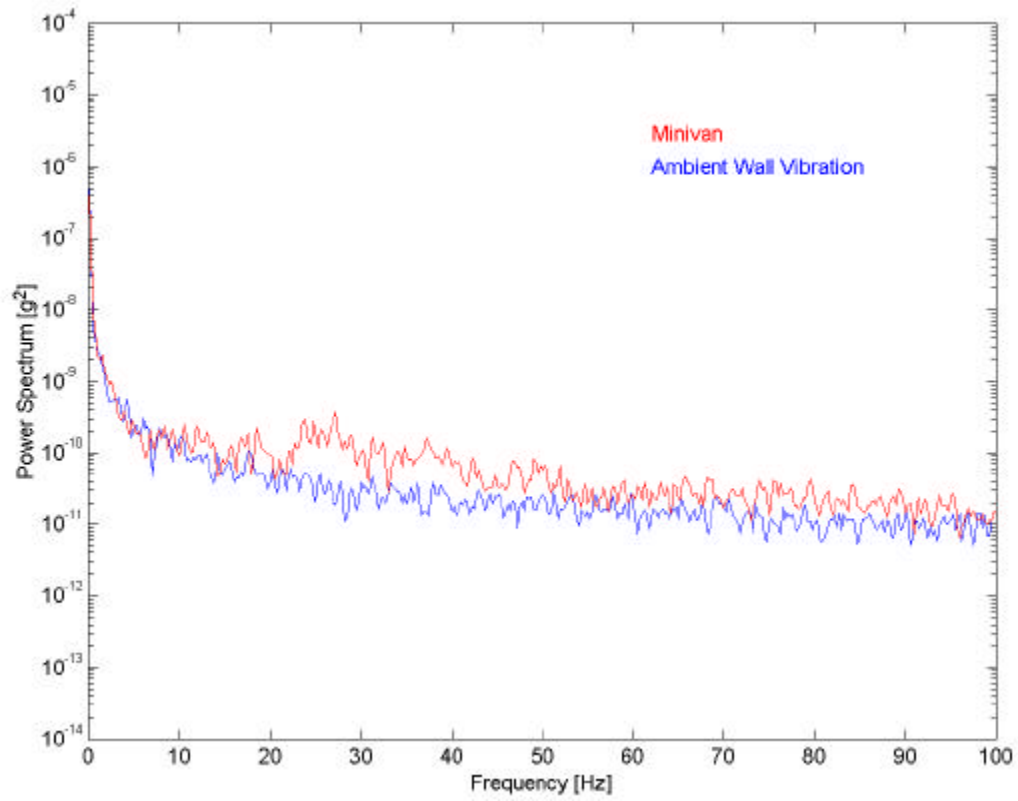
The measured acceleration responses both on the ground and on the structure caused by vehicle excitation, as compared to the background levels of vibration are shown in Figures 14 -18. It was not possible to compare the acceleration response on the structure when the milk truck was the excitation source since the data was inadvertently not taken. On average, all vehicles produced increased levels of vibration on the ground and on the structure as compared to the ambient levels of vibration.
